**PUBLIC SAFETY**  
**Fire Department**  
**Cash Corner Fire Station Renovation Project**

**Preliminary Design Report (PDR)**  
**Cash Corner Fire Station, South Portland, Maine**

Sebago Technics, Inc. in cooperation with Grant-Hayes Associates and Allied Engineering were retained by the City of South Portland to prepare a Preliminary Design Report (PDR) for improvements to the Cash Corner Fire Station. This planning level study is intended to provide the City of South Portland the information necessary to make an informed decision regarding the extent and probable improvements and associated costs for the renovation project. Following the PDR, the facility design, bidding and construction phase of the project will be undertaken should the City decide to move forward.

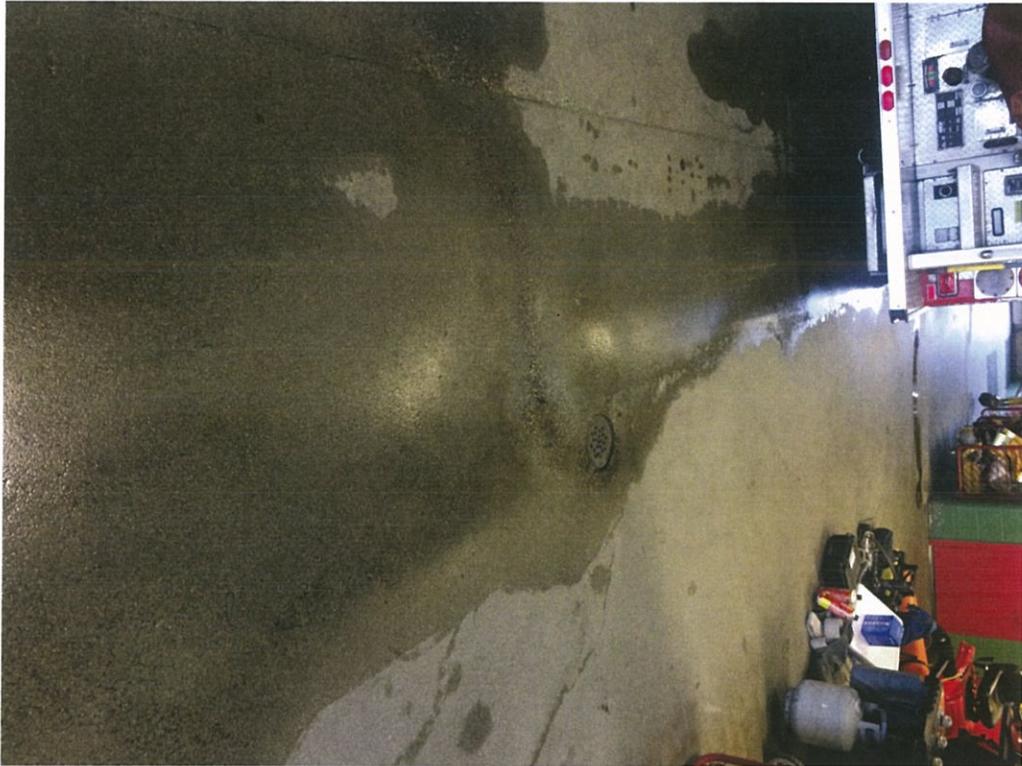
**APPARATUS BAY FLOOR DRAIN**

13. The Apparatus Bay does not have sufficient floor drainage, which can be hazardous at certain times of the year, particularly in the winter. Strategically placed trench drains would alleviate this problem.

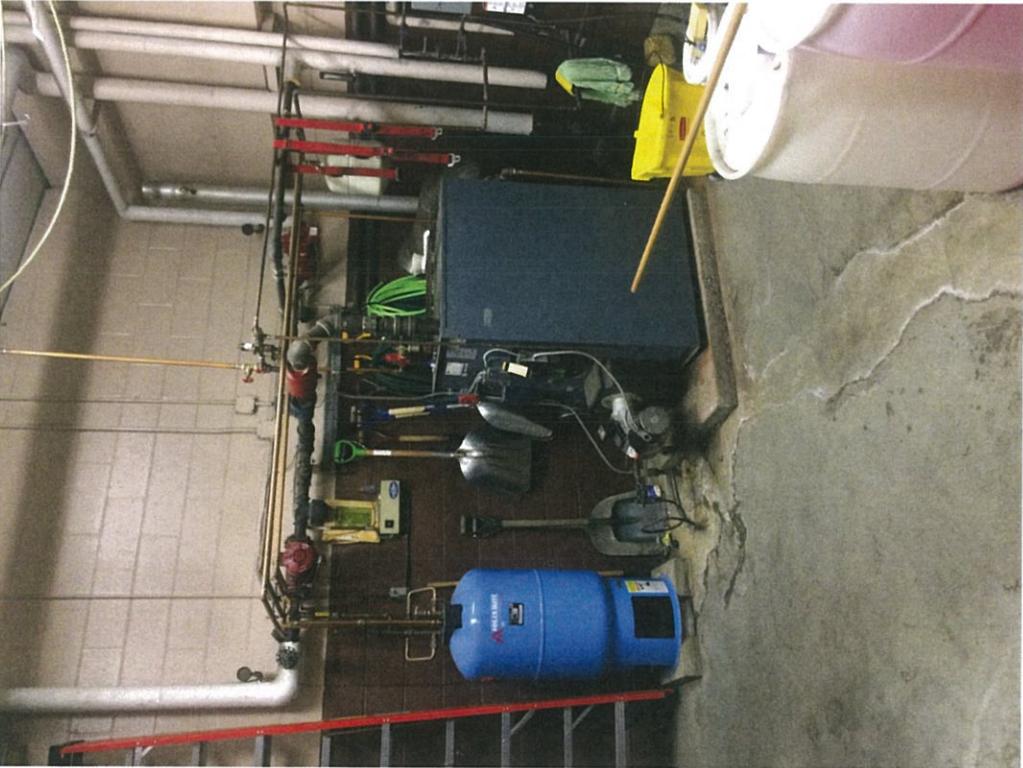
BOILER AT UTILITY ROOM

1. The heating boiler appears to be original to the facility and is beyond its published dependable service life.
2. The vehicle exhaust system at the Apparatus Bay has been installed since the building was constructed and appears to be in good overall operating condition. This is the only source of mechanical ventilation within the Apparatus Bay. There is no source of makeup air for the vehicle exhaust. Current ASHRAE Standards require that the total exhaust ventilation rate for this type of space be sized at .75 cfm per sf of floor area. That equates to approximately 2,100 cfm. Although we have no data on the exhaust fan, it is estimated, based upon the size of the ducts, that each of the three drops provide approximately 400 cfm, for a total of 1,200 cfm.

7. New ducted heat pumps to serve functional spaces.
8. Replace Oil fired boiler with new natural gas fired condensing boiler with new variable speed circulator pumps and new control valves.

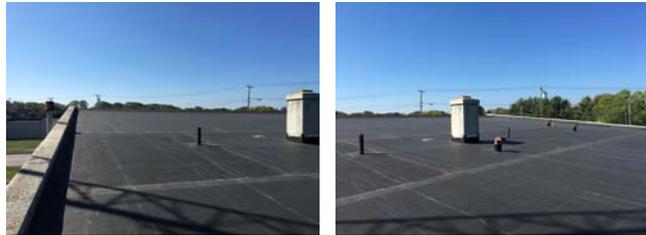
1. Main Roof – Area 1: The roof is surfaced with a 0.060 mil EPDM membrane surfacing applied over Polyisocyanurate insulation which is mechanically fastened to the metal decking system. The thickness of the insulation was not determined by AEI, but could be from a coring sample performed by a roofing contractor.

1. Main Roof – Area 1: The roofing appears to be beyond its useful life and should be replaced as a part of the planned renovation. The insulation in the field and along all four edges is soft underfoot, which is an indication that moisture has been present in this system beneath the membrane for some time. When the roof is replaced, consideration should be given to providing a minimum R-30 roof insulation application beneath a 0.060 mil EPDM or TPO roofing application. The new insulation would be mechanically fastened and the membrane adhered.

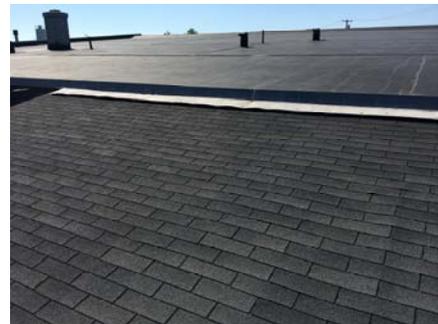
2. Sloped Shed Roof - Area 2: There is a low slope roof constructed off the left side of the building and aligned with the front wall. This roof structure is shingled with asphalt/fiberglass roof shingles that are in good shape.

2. Sloped Shed Roof - Area 2: This roof is in good condition, with the roof surface having in excess of 10-15 more years of service available. The breakdown in this system is the flashing between Area 1 and this roof. A parapet should have been constructed along this intersection to properly allow flashing and the Provided half-up roof vent to function as intended.

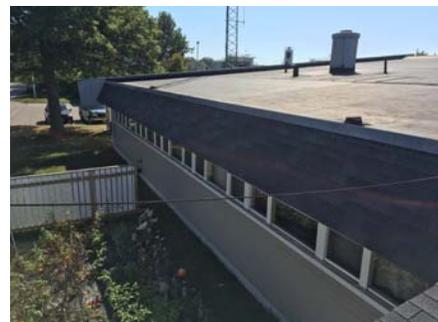
3. There are mansard roofs constructed along each of the left and right side main roof edges. On the left side, the mansard roof runs from the front to the rear. At the Area 2 shingled roof, this structure was built over the mansard roof and flashed into the main roof fascia metal.

The mansard along the right side of the roof edge is full length.

3. The mansard roofs along the left and right sides of the building are in good condition and should provide another 10-15 years of use.

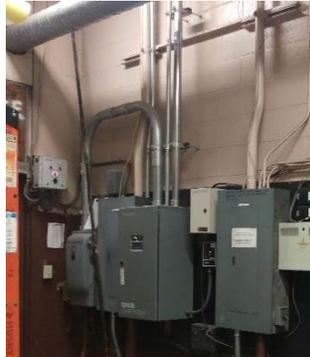
1. The building has a 200-amp 208/120-volt three-phase, four-wire underground service from primary overhead utility lines. The service originates at a bank of three utility-owned pole mounted transformers and terminates at a fusible switch that is located in the Boiler Room. Power is distributed from the service disconnect switch via an automatic transfer switch to branch-circuit panels E1 and E2 that are located in the Boiler Room, and E3 and E4 that are located in the kitchen area.

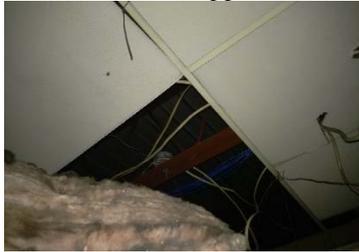
4. Receptacles appear to be located appropriately for the existing uses of spaces. Receptacles throughout appear to have proper grounding. Based on what can be seen from a simple walk-through of the facility, general wiring appears to be a mixture of building wire in conduit, type NM nonmetallic sheathed cable (commonly referred to as “romex”), and type MC metal-clad cable. The type MC cable appears to be limited to circuits that have been added in more recent years, whereas much of the type NM cable that can be seen appears to be original to the building.

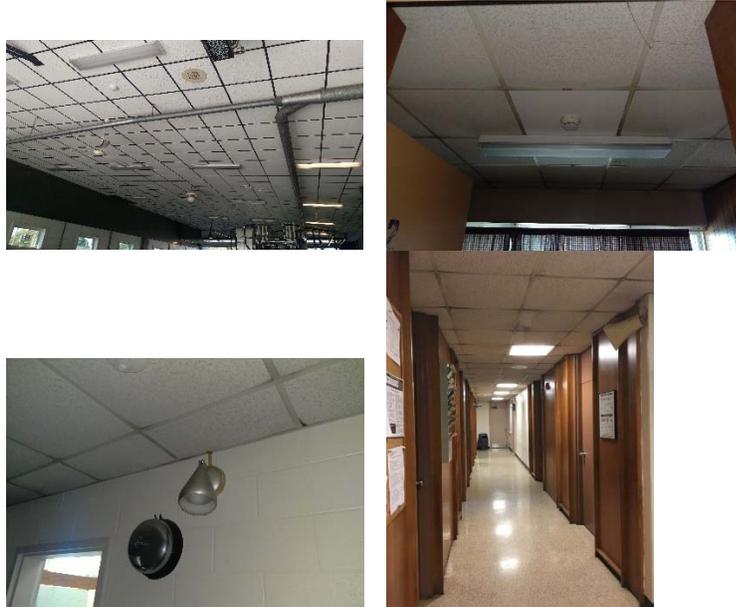
5. Interior Lighting is provided by a mixture of recessed troffers and surface mounted wraparound style luminaires that utilize linear T8 fluorescent lamps and, presumably, electronic ballasts. The fixtures appear to be older fixtures that have been retrofit with the T8 lamp/ballast systems. There is one incandescent luminaire in the corridor that is reportedly connected via the Zetron alert system to automatically turn on when the station receives an alarm. Except for the fixture connected to the Zetron alert system, the interior lighting is controlled by manual switches. There are no battery powered emergency lights for means of egress or internally illuminated exit signs marking means of egress.

5. The existing interior lighting fixtures are at or near the end of their anticipated useful lives and should be replaced as part of the renovations.

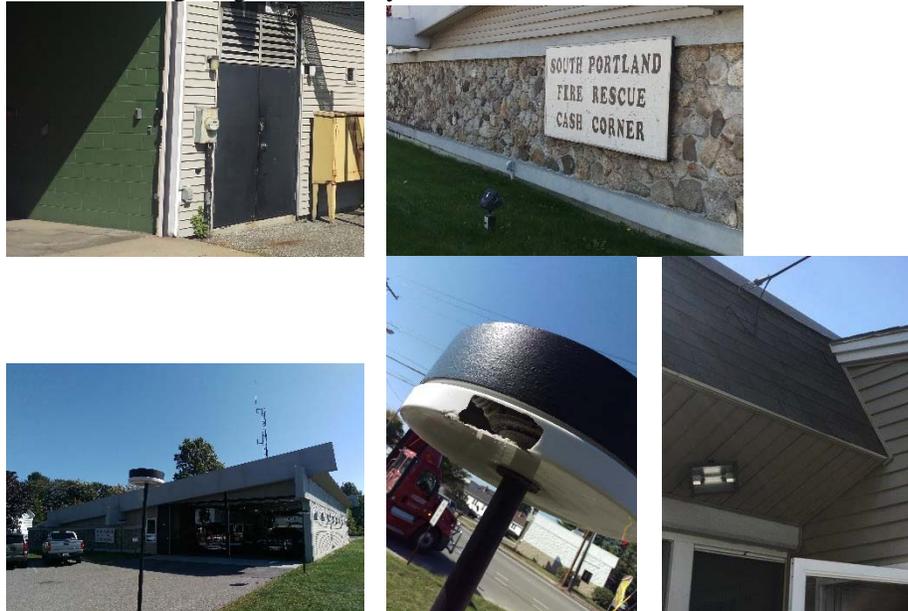
The exterior lighting varies in type, age and condition. Incandescent wall mounted fixtures that appear to be original to the building are installed at the rear entrance. A quartz halogen floodlight illuminates the outdoor garden. A ground mounted metal halide flood light illuminates the building sign. There are compact fluorescent pedestrian-scale pole lights at the front entrance drive; one of these has a broken lens. The exterior lighting is control by a time clock.

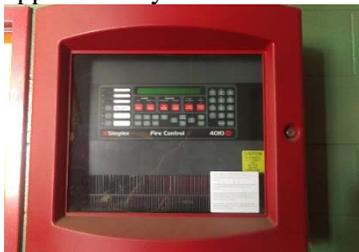
7. The facility is equipped with a Simplex addressable fire alarm system, but the system is not currently functioning, reportedly due to a defective mother board in the control panel. Occupant notification appliances are not located as would be required by current standards for a new facility; there are no notification appliances in the bunk rooms or apparatus bays.
