WILLARD BEACH WATERSHED ASSESSMENT EFFORTS (8/10/23)

Introduction

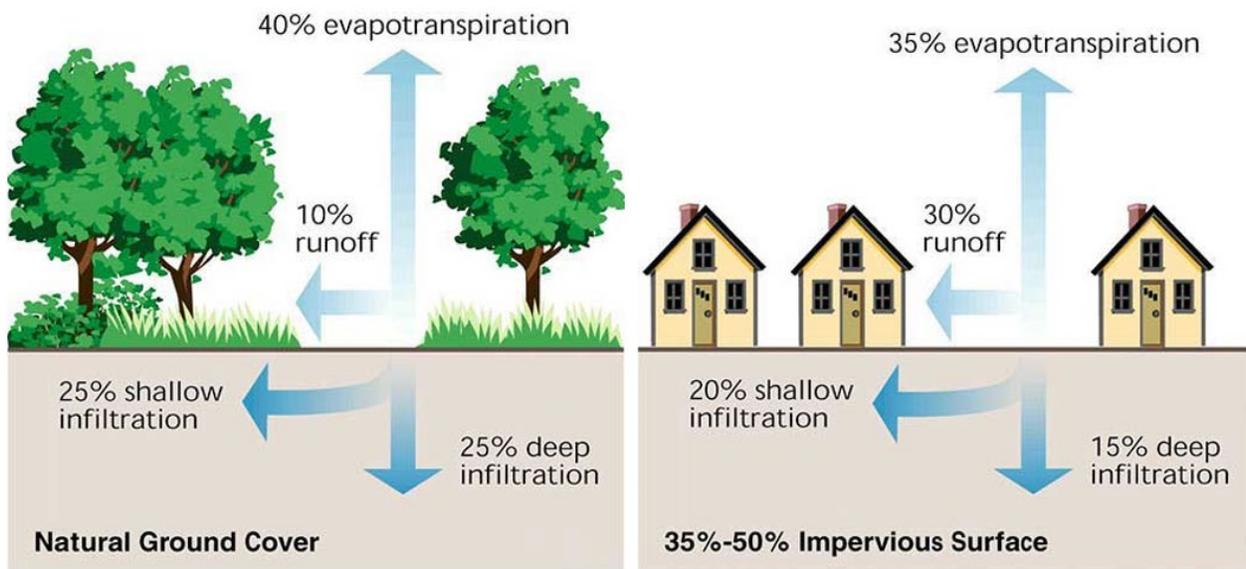
Figure 1: increasing development density increases the amount of stormwater runoff

Numerous studies have established a clear link between water quality and the extent of impervious surfaces, such as buildings and pavement (Figure 1). When impervious surfaces exceed 10% of a watershed area, water quality and aquatic health begin to decline. Approximately 41% of the Willard Beach watershed (~92 acres) consists of impervious surfaces (Figure 2). Consequently, during significant rain events pollutants such as fertilizers, petroleum products and animal waste are carried by stormwater into the storm drain system which directly discharges into the ocean (Figure 3).

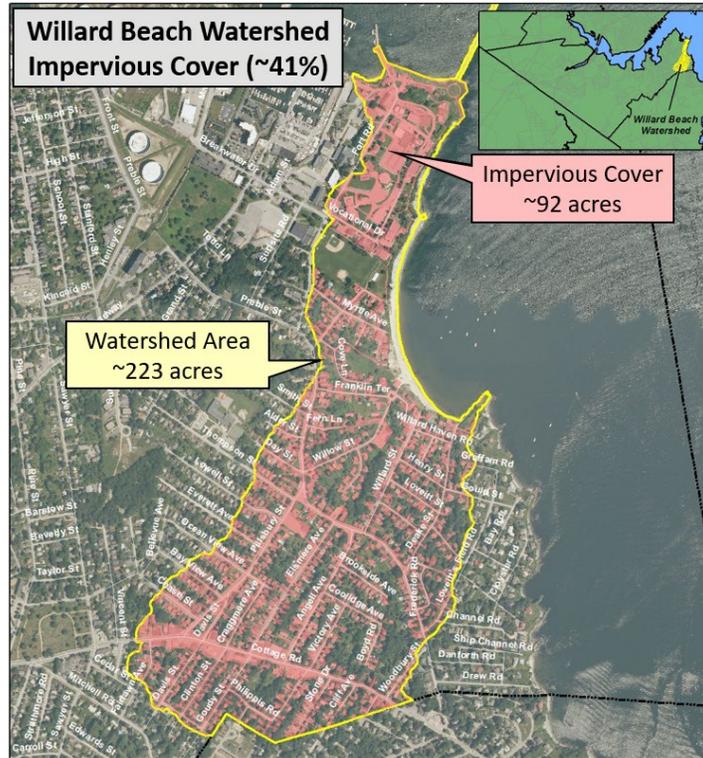
Figure 2: Willard’s watershed has a significant amount of impervious area (in pink)

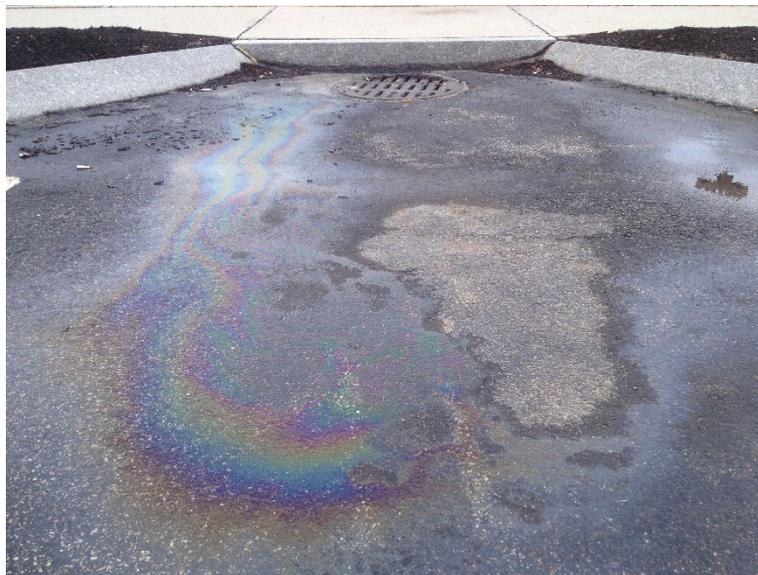
Figure 3: petroleum products entering the stormwater system

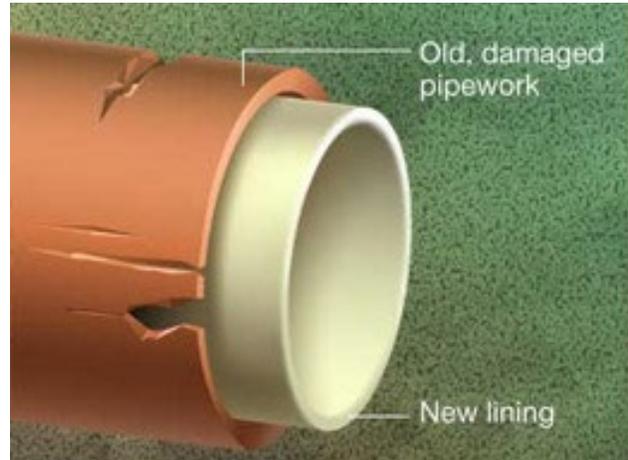
Figure 4: new plastic pipe lining inserted into existing clay pipe

The City has completed several watershed assessments to inform asset management decisions. Virtually all of the sewers and many of the storm drains owned by the City [have been visually inspected with specialized cameras](#) to determine pipe conditions, including in the Willard Beach watershed. Condition assessment is a critical part of the City's asset management program, which provides a rational basis for the most efficient and effective allocation of limited financial resources to meet key water resource protection goals. Based on these evaluations, the City has developed a prioritized list of sewer mains to repair by lining the inside of the existing pipe, which minimizes the need for excavation and traffic disruptions (Figure 4). In 2022, the City invested over \$300,000 to line approximately 1,400' of sewer mains at several Willard Beach locations.

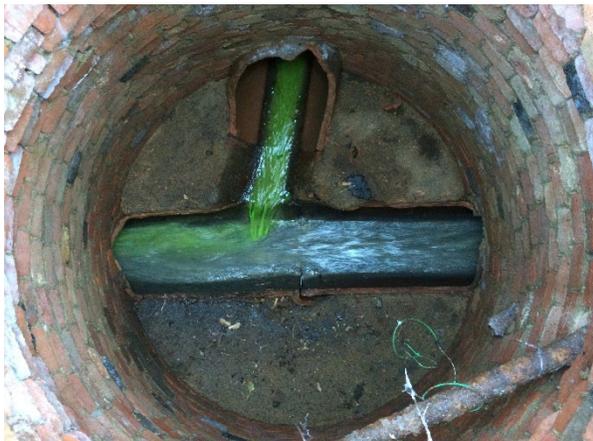
Figure 5: fluorescent dye in drain manhole

Over the past **10 years**, the City has partnered with MHB to conduct water quality sampling throughout the Willard stormwater system. The results of this effort are published in a [2020 MHB report](#). In addition, we have used fluorescent dye and specially trained dogs (Figures 5 & 6) in our sewer and storm drain systems to confirm and remove sewage sources from the stormwater system.

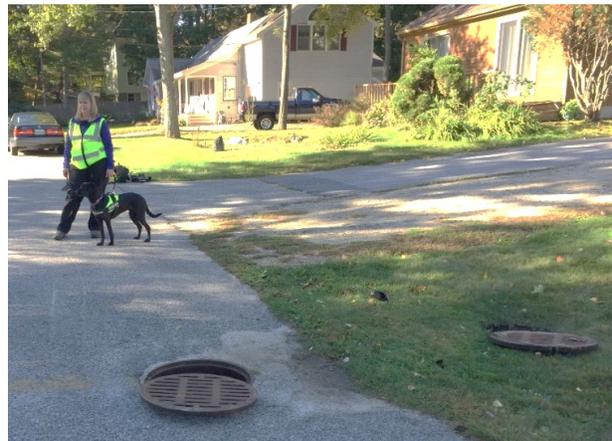
Figure 6: dogs investigating storm drain system
