**PUBLIC SAFETY**  
**Fire Department**  
**Cash Corner Fire Station Renovation Project**

**Preliminary Design Report (PDR)**  
**Cash Corner Fire Station, South Portland, Maine**

Sebago Technics, Inc. in cooperation with Grant-Hayes Associates and Allied Engineering were retained by the City of South Portland to prepare a Preliminary Design Report (PDR) for improvements to the Cash Corner Fire Station. This planning level study is intended to provide the City of South Portland the information necessary to make an informed decision regarding the extent and probable improvements and associated costs for the renovation project. Following the PDR, the facility design, bidding and construction phase of the project will be undertaken should the City decide to move forward.

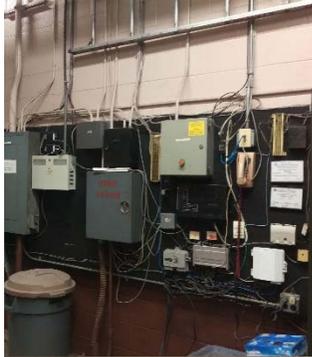
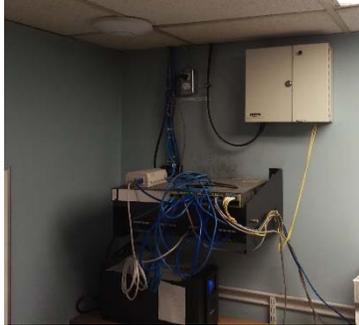
6. The building has an underground telephone service in what appears to be a 1-1/2" conduit that originates at the same utility riser pole as the electrical service and terminates within

the Boiler Room. Cable television (CATV) service is overhead and enters the building above the ceiling at the southeast corner of the day room. A fiber optic data cable from the high school building also enters the building overhead above the ceiling at the east side and terminates at a wall mounted patch panel located in the office.

7. The facility is equipped with a Simplex addressable fire alarm system, but the system is not currently functioning, reportedly due to a defective mother board in the control panel. Occupant notification appliances are not located as would be required by current standards for a new facility; there are no notification appliances in the bunk rooms or apparatus bays.
